Manhole Inspection Summary

Manhole # S53C__030MH

Insp Date: **6/13/08 12:33 PM**

Location Address: **rear 3034 e baltimore st**

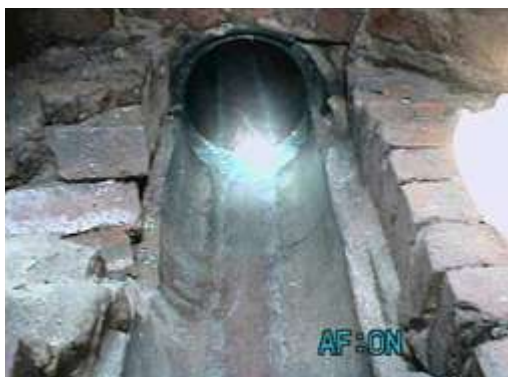
Defect 3

Condition: ☐ Sound ☐ Cracked ☐ Root Intrusion ☒ **Deteriorated** ☐ Leaks ☐ Debris

bench deteriorated

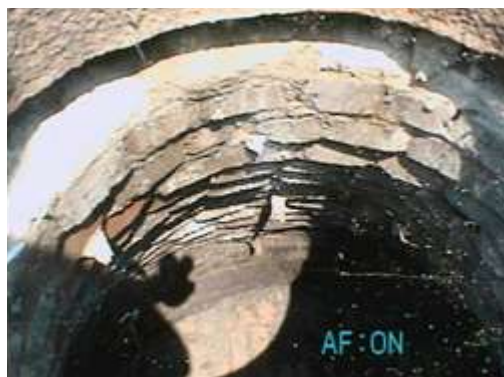
Defect 2

Condition: ☐ Sound ☒ **Cracked** ☐ Root Intrusion ☒ **Loose Brick** ☐ Deteriorated

Steps Count: **3** Missing: **3** ☒ **Corroded**

corroded, missing steps & chimney loose bricks and cracked, frame adj

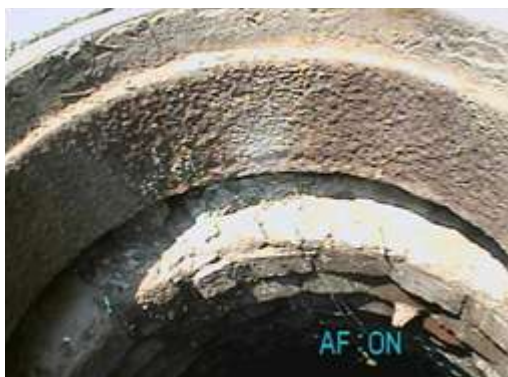
Defect 1

Frame Offset: **2** (in.) Condition: ☒ Sound ☐ Cracked ☐ Leaks

offset
